## THE EVIL MAGNET

Four cases in which IOLs behaved like magnets inside the eye by attracting deposits that might affect the patients' vision.

BY RINAL PANDIT, MBBS, MS, FMRF, FAICO, AND DEEPANSHU AGRAWAL, DO, DNB, FVRS

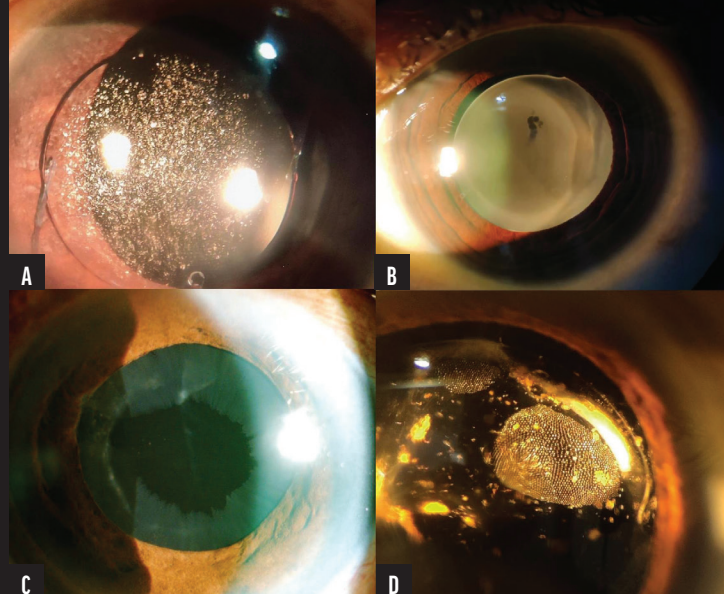
▶ Figure. Four years after cataract surgery, anterior dislocation of a multi-piece IOL with multiple glistenings is observed in a 62-year-old man (A). A one-piece hydrophilic acrylic IOL with an opacified optic is well positioned in the bag in the eye of a 78-year-old man 8 years after cataract surgery (B). A peripheral circumferential pattern of pseudoexfoliative deposits is visible on the anterior surface of an IOL in the eye of a 70-year-old woman (C). A honeycomb pattern of residual silicone oil droplets is seen on an IOL in the eye of a 60-year-old woman who underwent retinal detachment repair with silicone oil tamponade (D).

A slit-lamp examination revealed an anteriorly dislocated multi-piece IOL with multiple glistenings (Figure A). These fluid-filled microvacuoles (10–20 μm) can develop within an IOL optic as early as 1 week postoperatively, and they tend to increase in size and density over time.<sup>1</sup> Glistening formation is attributed to temperature fluctuations during the manufacturing or storage of lenses and may be linked to the injection molding process used in IOL production. Although most patients' distance visual acuity is unaffected,<sup>2,3</sup> glistenings can reduce the

Upon examination, the IOL was well positioned in the capsular bag, but the lens optic was opaque (Figure B). According to the patient's previous records, the implant was a one-piece acrylic hydrophilic IOL.

on the lens' anterior surface in a peripheral circumferential pattern, suggestive of pseudoexfoliative deposits (Figure C). Glaucomatous changes to the optic disc and significant thinning in the inferior quadrant of the retinal nerve fiber layer were noted. The patient was diagnosed with pseudoexfoliation glaucoma and underwent structural and functional testing. Medical therapy was initiated.

A 60-year-old woman underwent retinal detachment repair with silicone oil tamponade. Three months later, the silicone oil was removed, and cataract surgery with implantation of an AcrySof IQ lens (model SN60WF, Alcon) was performed. One month later, a honeycomb pattern of residual silicone oil droplets was observed on the IOL (Figure D). The deposits were peripheral to the visual axis and did not cause visual impairment. Because the visual axis was not obscured, we opted for observation without further intervention.
